March 18, 2002

**RE: EVALUATION OF MASS WASTING, BRANSON PROPERTY,
BURIEN, WASHINGTON**

Burien Parks Department
Branson Property
Burien, Washington

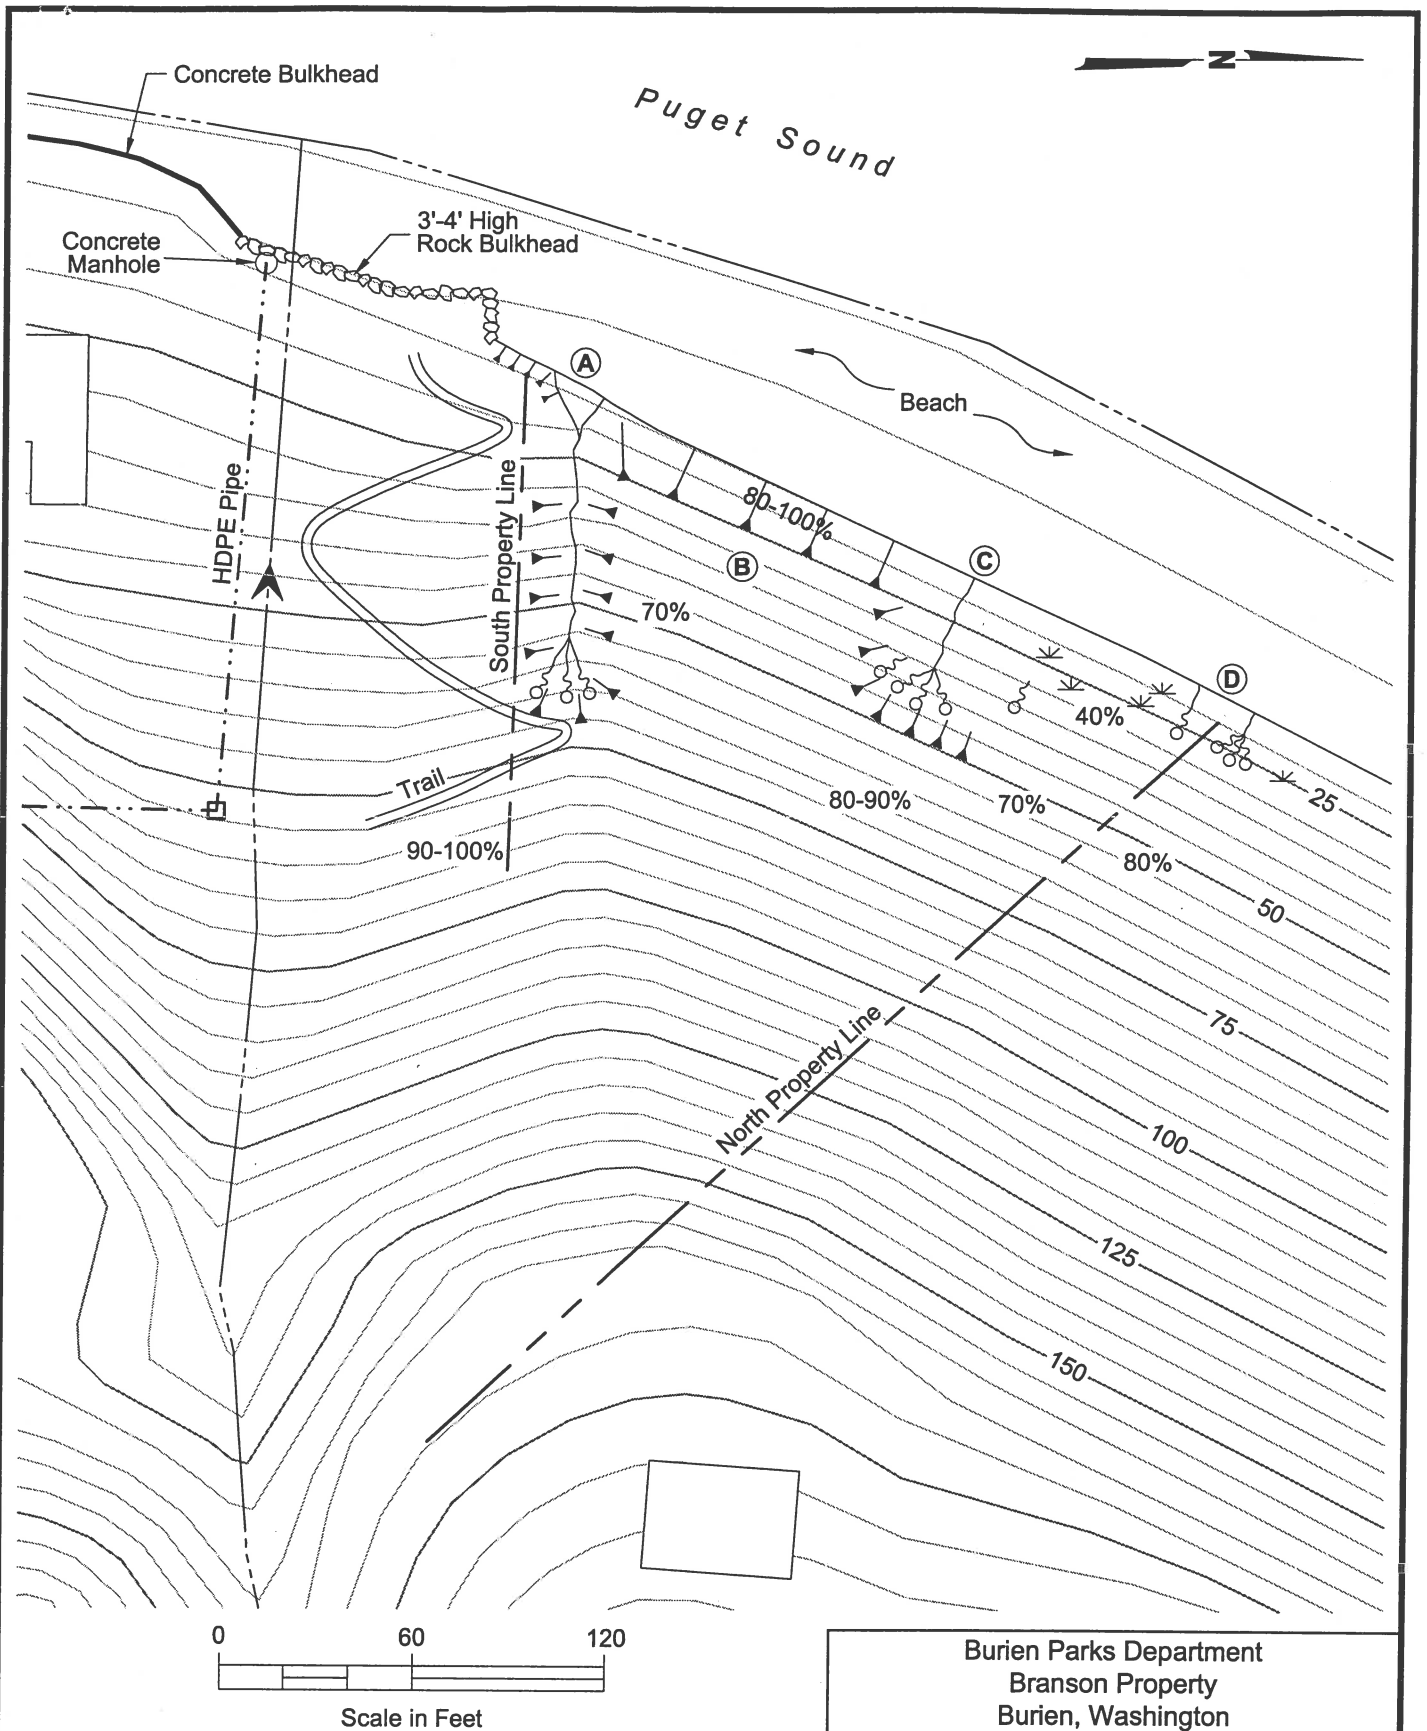
FIG. 2

Groundwater was observed at about elevation 65 feet at the head of a small chute near the southern property line. The springs form a small creek that runs down the chute to the shoreline. In the central portion of the site, at about elevation 40 feet, springs emerge from the hillside in an area about 40 feet wide. Their waters coalesce and flow to the shoreline in a small creek. Near the north property line, diffuse water emerges from the gentle slope at about elevation 25 feet. This water flows to the beach in two places, as shown on Figure 2.

- (1) At the south edge of the site, a debris chute is present. Such a chute empties periodically, depositing soil at the toe of the chute. A debris deposit is present at site A, as indicated on Figure 2. The debris deposit is comprised of a fan of very loose, silty, gravelly sand. The toe of the deposit is being eroded by storm waves. There is evidence that such a process has also occurred at the head of the central springs, but no debris deposits remain at the toe of the slope, presently. However, the presence of gravel throughout the length of the small creek indicates that gravel is delivered occasionally to the beach.

- (2) At site B, which appears to be a thick landslide deposit, the toe of the slope is oversteepened and cut by arcuate bowl-shaped slumped areas. These features are indicative of local undercutting by storm wave action and/or slumping due to local seepage pressures. The materials that comprise this very steep bank are clean to slightly silty, gravelly sand.

- (3) At sites C and D, the spring-fed creeks are actively carrying silt, fine sand and fine organics to the beach. In some cases, the fine sediment is temporarily blocked by logs on the beach, but this material is then periodically entrained by storm waves.
