Subject: Letter Report
Eagle Landing Landslide Evaluation
Burien, Washington
File No. 3416-053-00

Eagle Landing Landslide Evaluation
Burien, Washington

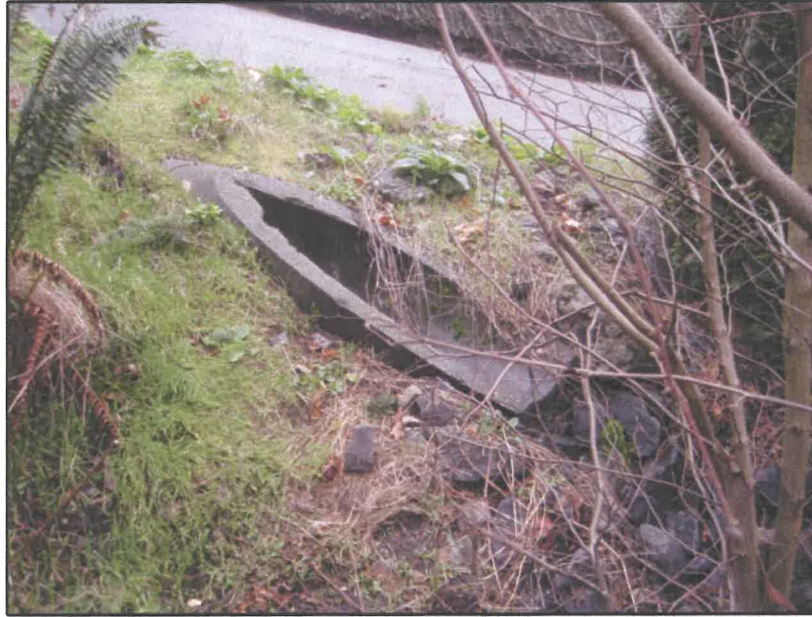
Beginning from the parking lot we observed the stormwater drainage system, a concrete, 12-inch drain pipe exposed under the western edge of 25th Avenue SW. The culvert drains to a rock lined channel running roughly parallel to the trail entering the park and continues downslope for about 150 feet, from there it flows into a culvert under the park trail and continues west (downslope). The channel includes channel-grade control structures spaced about 15 to 20 feet apart. Midway down the rock-lined drainage it appears as though grade control structures were once in place but have degraded from recent/past high flows. We also observed minor erosion on the park trail (about 6 inches wide, 3 inches deep), parallel to the rock-lined channel (see Figure 2). From the culvert placed under the trail we followed the drainage and could see that limited erosion has occurred in some areas immediately down slope of the culvert, including areas of incision up to 2 feet deep. The drainage is approximately 1 foot wide downslope of the culvert and becomes progressively shallower with distance downslope of the trail. Evidence of the surface flow is visible for approximately 50 feet downslope from the culvert and then evidence of channelized flow disappears as the water apparently infiltrates into the surface soils.

View of the 12-inch concrete stormwater drainage pipe where it begins to drain into Eagle Landing Park, located on western edge of 25th Avenue SW.

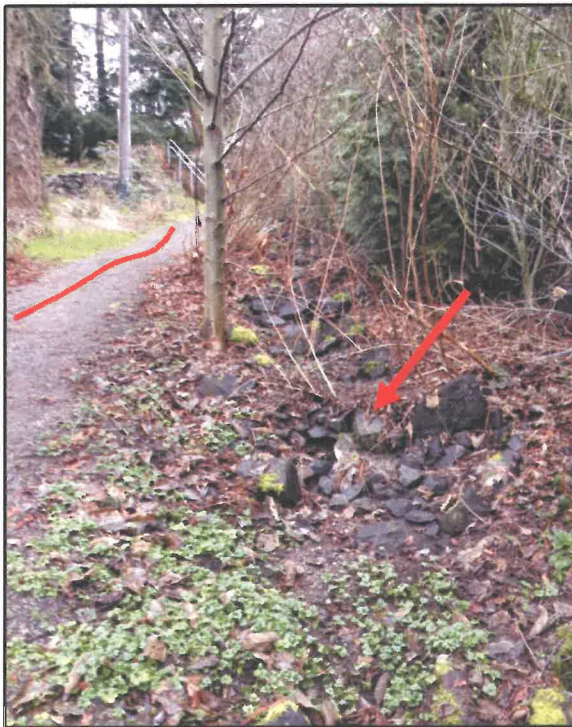
The stormwater drainage system has caused minor erosion in the upland area of the park boundaries but it appears as though the flow infiltrates, and signs of erosion dissipates about 225 feet downslope from where the discharge begins near the parking lot.

View upslope of the drainage and minor erosion in the trail (outlined in red). The drainage is rock lined and appears to contain grade-control structures (red arrow) that have begun to degrade. Photo taken facing toward the east.

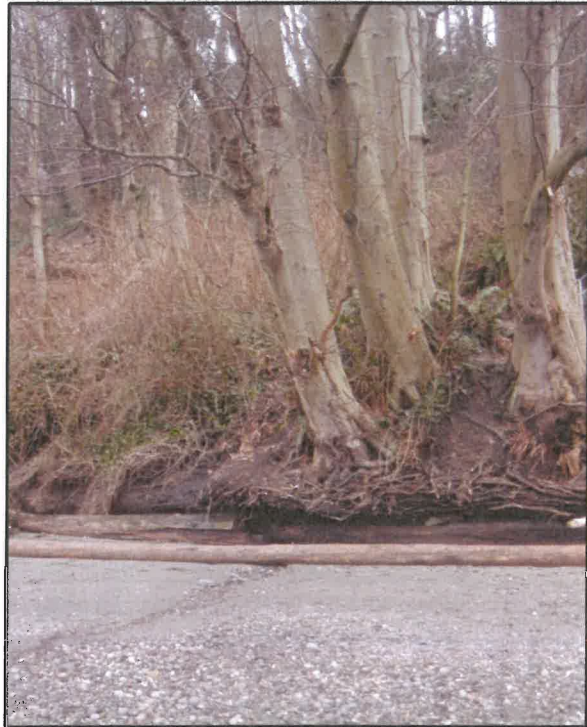
Along the beach we observed multiple seeps, exposed tree roots, bowed and leaning trees, and evidence of active beach erosion along the toe of the slope (see Figure 3). At the base of the stairs there is an approximately 4-foot vertical drop to the beach and the toe of the slope adjacent to the stairs is undercut with vertical relief from about 1½ to 3 feet. In the exposed slope we observed colluvium in the upper 2 feet, underlain by silty sand. We used a soil probe in an eroded side wall of the slope to estimate the density of the material and found that it easily penetrated at least 3 feet into the slope. What appears to be a recent slope failure just south of the staircase is about 30 feet wide and 12 feet at its maximum height (see Figure 3). The small failure we observed to the south of the staircase is perhaps as little as 20 feet from the second stair landing upslope from the beach.

Wave erosion on the beach is undercutting the base of the slope. Note about 1½ feet of vertical beach erosion at base of the slope. Tree roots are exposed and trees are bowed and leaning.

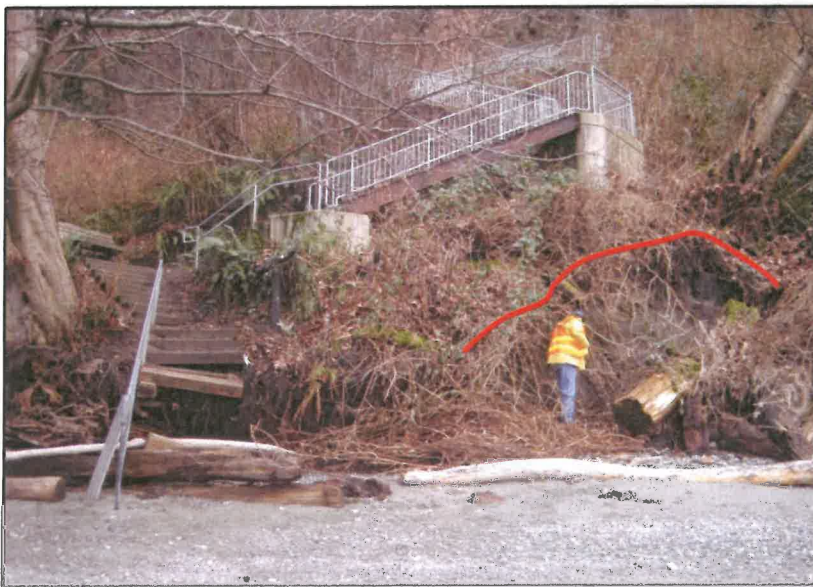
Based on our review of available information and our site reconnaissance, it is our opinion that the landslide will likely continue to fail in the short and long term (i.e., within months to years). The eagle perch tree located upslope of the landslide is back-tilted, has exposed roots and is likely to fail as a result of headward retreat of the landslide headscarp, or because of windthrow. We also found that the base of the tree was about 15 feet from the top of the slide which is less than the observed 30 foot distance reported by Gilles, indicating that the headscarp has retreated approximately 15 feet over a period of a few weeks. In addition to the eagle perch tree, there were several trees with undercut root systems observed along the shoreline area that may, over time, present a safety hazard to the public. The small failure located south of the staircase could encroach on the second landing. Depending on the foundation details, this failure could undermine the landing foundation.

View from the beach at Eagle Landing Park. Note undercutting of the slope, about 3 to 4 feet of vertical erosion, and slope failure to the right of the staircase (outlined in red). Photo taken facing toward the east.

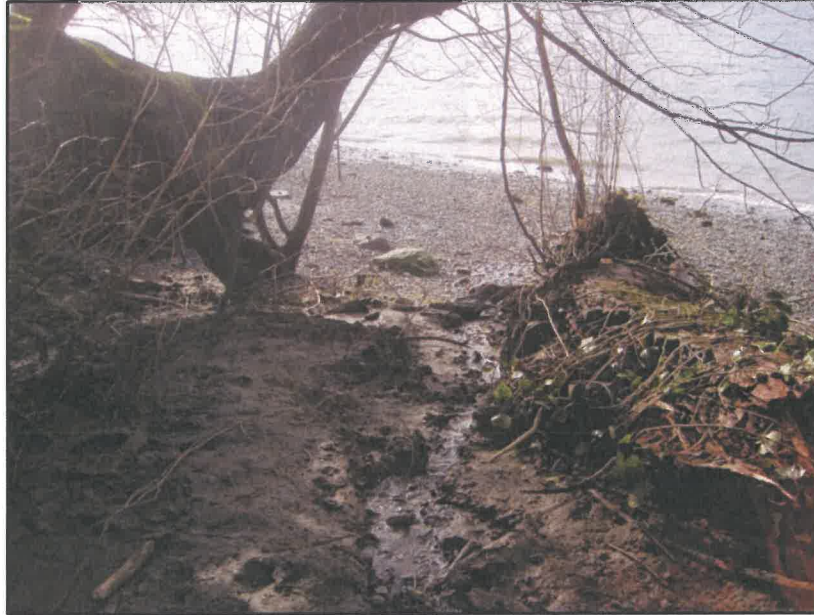
Portions of the scarp are covered by dense foliage that has draped over the slope and edges of the chute (see Figure 5). At the time of our visit, we observed seepage from the body and toe of the landslide debris flowing at approximately 30 gallons per minute. The debris at the toe of the slide is composed of sand with gravel, cobbles, and woody debris.

View of the toe of the landslide, debris are actively being down cut by seepage flow. Photo taken facing west-southwest.

We considered conceptual mitigation alternatives to stop the landslide activity at the site. The most reasonable and probably least expensive option would be to remove loose material within the body of the landslide and fill the landslide scar with light loose rip rap and/or large quarry spalls placed over a filter fabric. This would allow the water to continue to drain from the slope face, but prevent future collapse of the slope surrounding the landslide scar. Construction would be difficult because of limited access to the site (which would be difficult for any alternative), difficulties associated with moving material into and out of the landslide, and tidal action on the beach. It is likely that any alternative will be fairly costly (more than \$100,000).

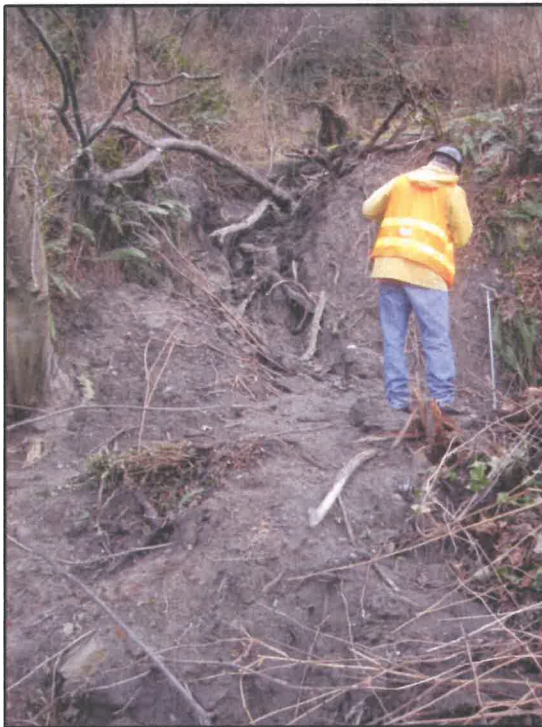
View of the landslide debris located about mid-way up the landslide. Photo taken facing towards the east.

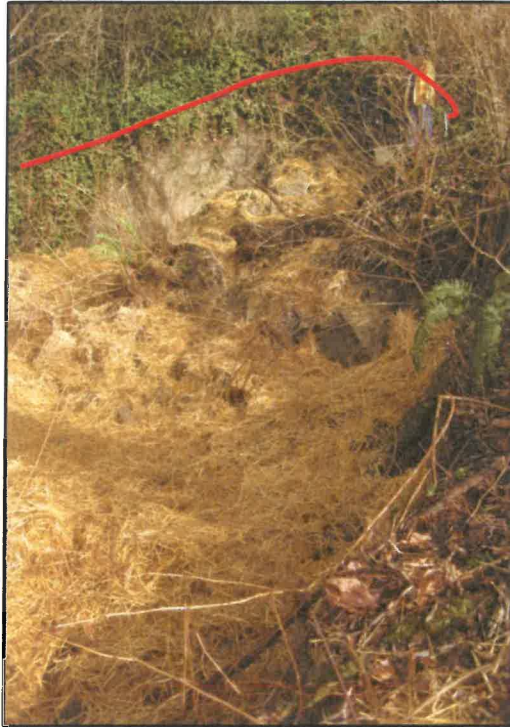
The larger subject landslide, located at the southern edge of the park boundary, measures approximately 88 feet (slope length) from the headscarp to the toe of the landslide. The toe of the failure was about 34 feet wide; the head had a maximum width of about 40 feet. A narrow debris shoot leads from the wider head of the failure to the toe of the feature. A bench is located approximately 30 feet (slope length) above the beach where the chute narrows to about 6 feet wide (see Figure 4). A second bench is located another 45 feet upslope of the first bench (75 feet upslope from the beach). At the second bench, the landslide widens into a bowl shape, forming the head of the landslide. The scarp at the head of the landslide exposes nearly 10 vertical feet of the underlying stratigraphy. Exposed in the scarp were inter-bedded silt and sand layers, with seepage emanating from the sandier strata.

Partial view of the landslide headscarp (outlined in red) and straw- covered head of the landslide. Photo taken facing east.

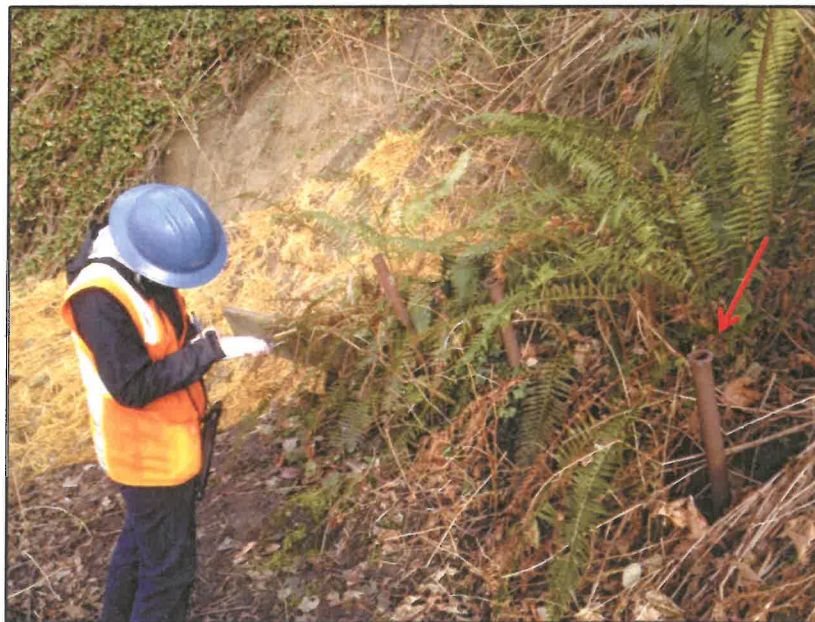
Near the head of the landslide there are multiple tiers of near-vertical steel pipe and lumber that appear to have been installed to retain sediment and debris; these features were still partially intact on the south edge of the landslide but were apparently damaged by recent landslide activity.

View of the headscarp in background, and what remains of the pipe and wood feature that is placed across the slope (red arrow points to pipe sticking out of slope). Photo taken facing north.
