January 5, 2015

City of Burien
400 SW 152nd Street, Suite 300
Burien, Washington 98166-1957

Subject: Memorandum
Eagle Landing Landslide Evaluation
Burien, Washington
File No. 3416-053-04

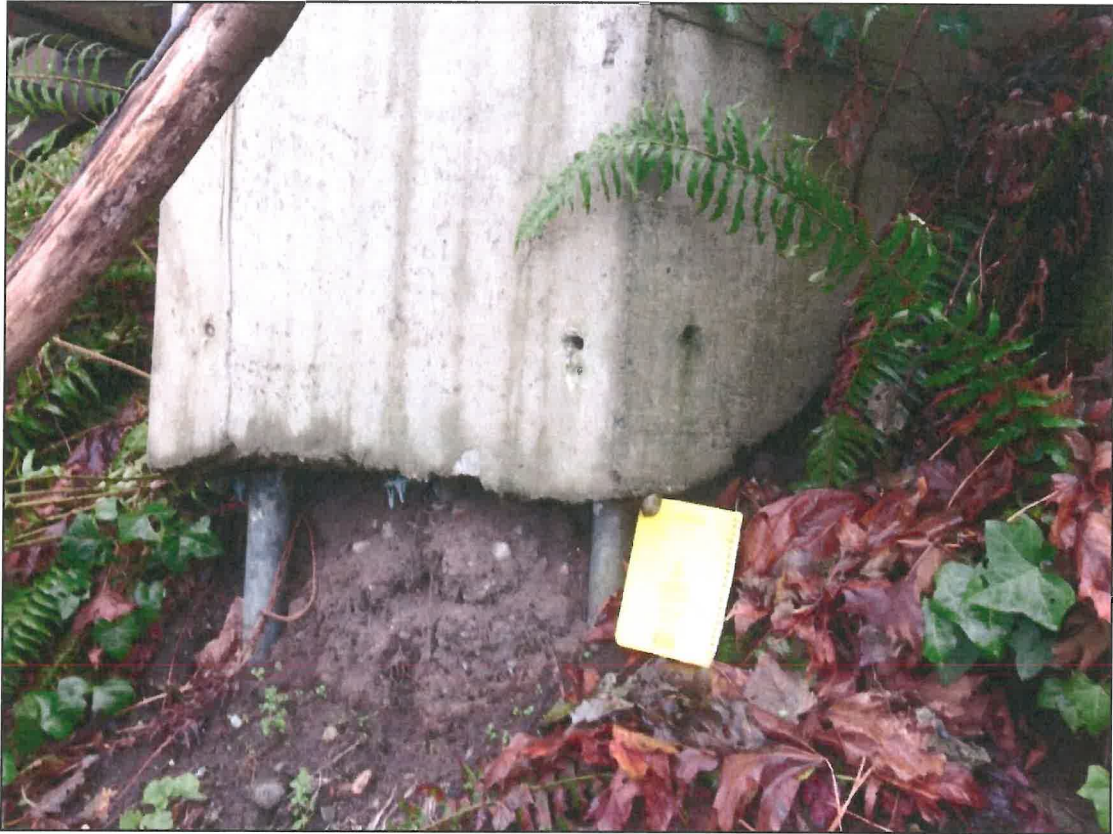
Site Photographs	
Eagle Landing Landslide Evaluation Burien, Washington	
GEOENGINEERS  	Figure 2

We visually inspected the stairs and concrete support platforms. We observed that erosion and soil creep has exposed up to 6 inches of the base of the concrete platforms for most of the stairway (Figure 2). We did not observe cracks or indication of movement for most of the platforms. Near the base of the slope, we observed that recent wave action had removed soil from the toe of the slope and from around the two concrete platforms at the base of the staircase, exposing the steel piles beneath the platforms. It appeared that the second platform from the bottom has been rotated by the slope movement and has detached from the stairs above (Figure 3). We were not able to access the beach due to high tides, but we did observe several recently downed trees along the beach, north of the stair access. We also observed that portions of the slope at the base of the stairs has been undercut several feet by wave action.

Typical erosion and soil creep observed at the base of one of the stair concrete platforms.

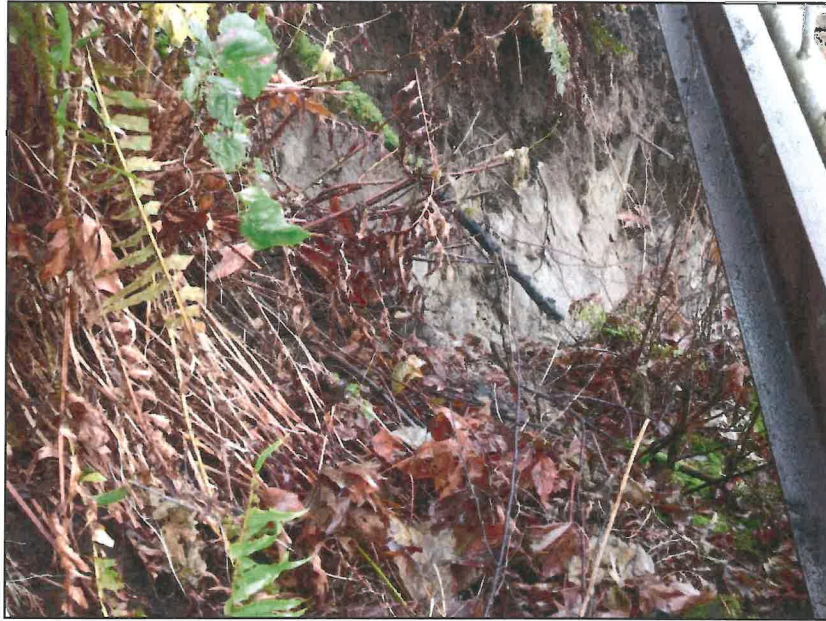
Toe slope below second platform eroded by wave action with vertical cut of up to 3 feet.

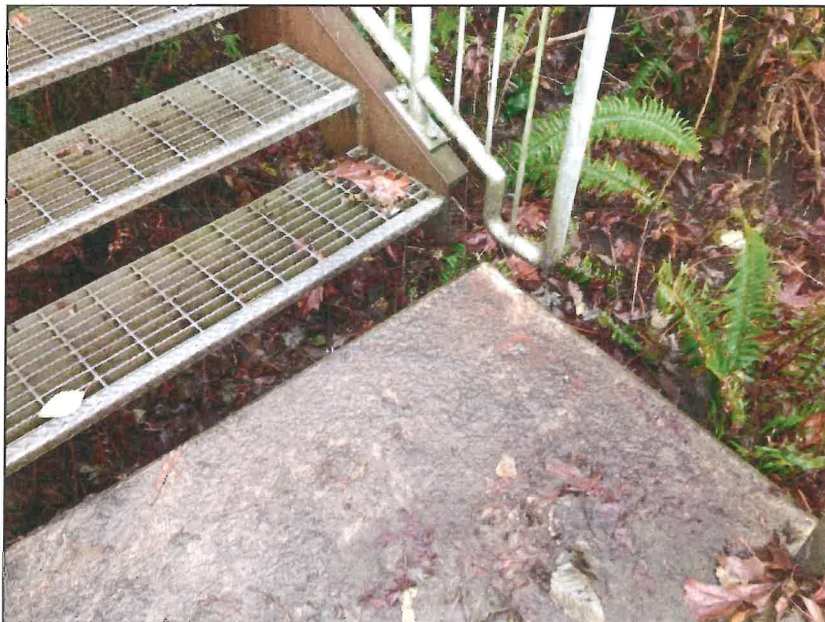
Detached stair at the second platform from the bottom of the slope.

Based on the results of our site reconnaissance, it is our opinion that the recent slope failure and landsliding will likely continue in the short and long term (i.e., within days to years). As a result, it is our opinion that the City should keep the stairs to the west-facing slope and access to the beach closed. The recently observed separation of the stairs from the second platform, the recently fallen trees along the beach and the slope, the current slope activity and the potential for continued slope movement represents a hazard to public safety along the slope and on the beach. It is also our recommendation that a new route down to the beach not be developed at this time. It is our opinion that an alternate route to the beach could be assessed during drier weather conditions in 2015. Additional slope evaluations should also be conducted when the tides allow for beach access.

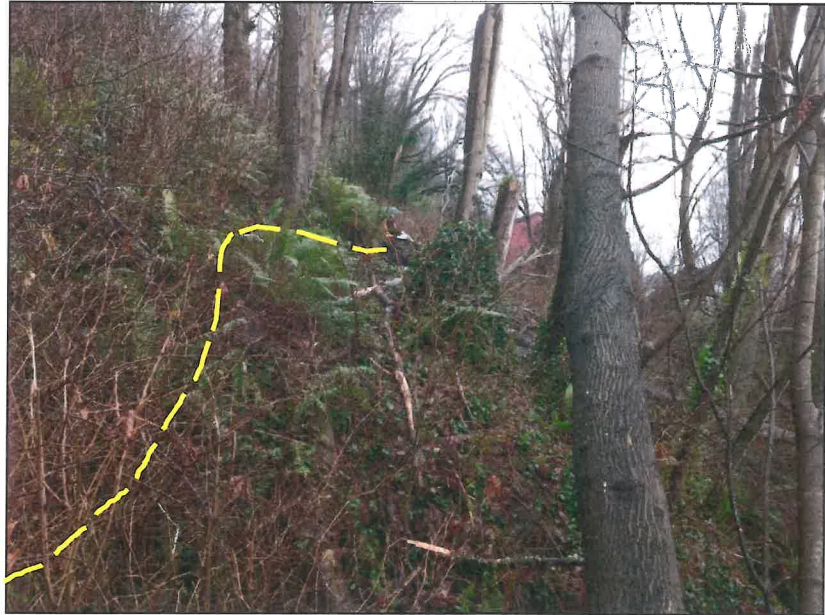
We observed a ground crack that propagated from the toe of the landslide at the face of the exposed slope between the first and second platform (looking upslope from the beach). The crack continued under the stairs between the second and third platforms and within 5 to 10 feet of the fourth platform for about 25 to 30 feet. The ground crack then propagates to the southeast and upslope for about 25 feet, travels subparallel to the shore for about 25 feet, and then curves southeast for an estimated 15 feet, where it intercepts the 2012 landslide (Figure 4). The crack ranged from 1 to over 6 feet in depth, and from about

Approximate trace of ground crack. View facing southeast from the 2nd platform from the bottom.

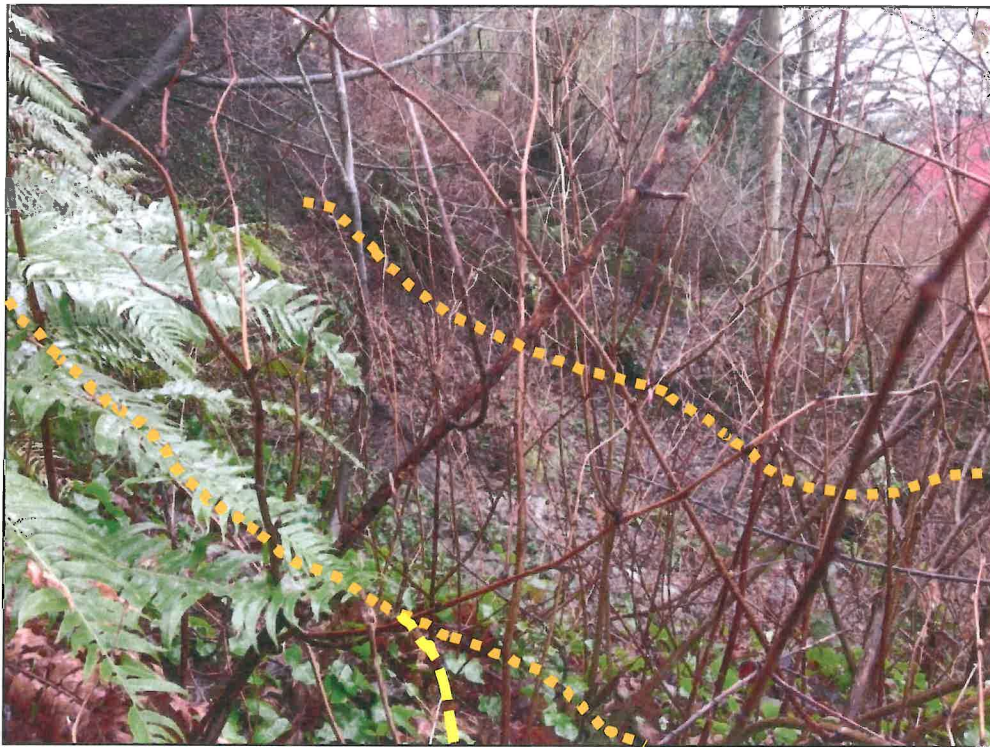
We also observed the 2012 landslide during our December 18, 2014 site reconnaissance. As noted above, recent 2014 crack and failure scarp intercepted the northern sidewall of the 2012 slide area (Figure 4). Evidence of very recent slope movement was observed, including fresh mounds of loose soil and exposures of clay (Figure 6), a fresh scarp having a minimum of 15 feet of relief (Figure 6), and recently fallen trees along the sidewalls. Farther upslope of this area, occasional healed slumps were observed with old scarp lines spanning a distance of up to approximately 20 feet (Figure 7).

Approximate location of 2014 ground crack intercepting 2012 landslide and 2002 debris chute area, near the southern end of the park property (orange dotted line outlines general north and south landslide limits, yellow dashed line is approximate trace of 2014 ground crack). View to the southeast.

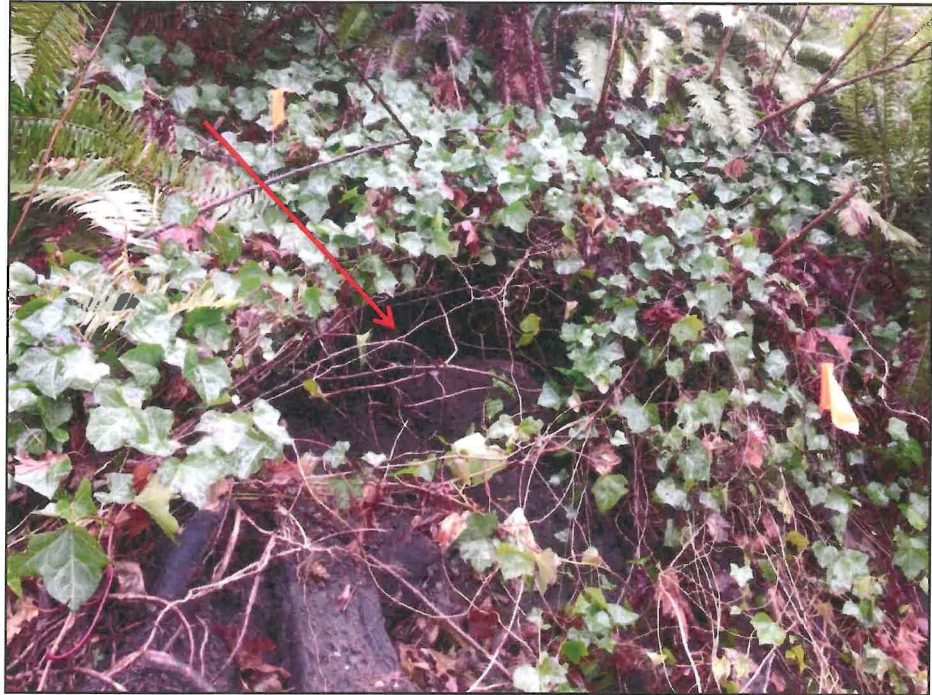
6 inches to at least 3 feet in width and was often off-set vertically approximately 1 to 4 feet downslope. Many recently-fallen trees were observed in areas that were off-set 3 to 4 feet (Figure 5).

Observed ground crack approximately 1 foot wide and 4 feet deep.

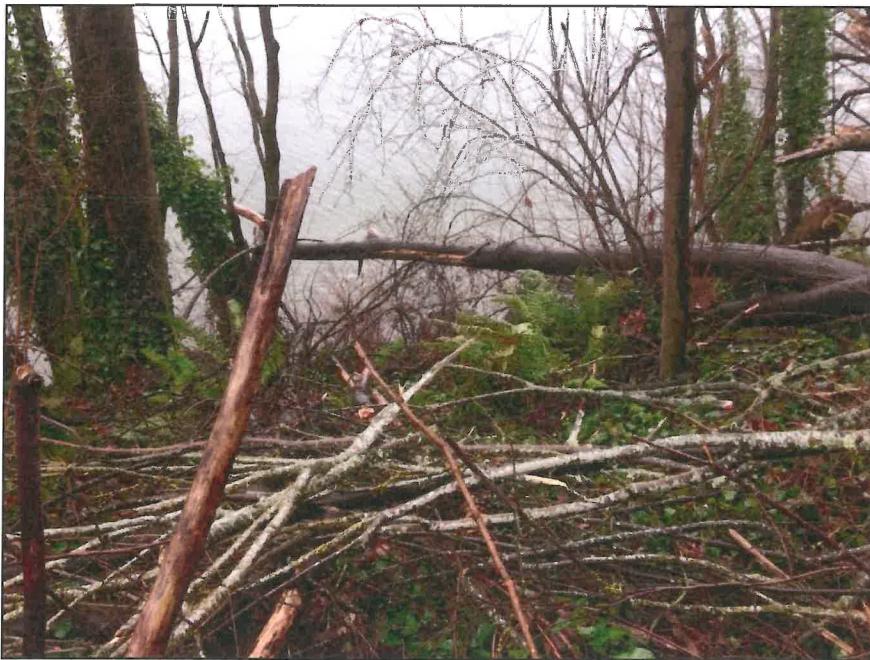
Recently downed trees within slide. View facing west-northwest.

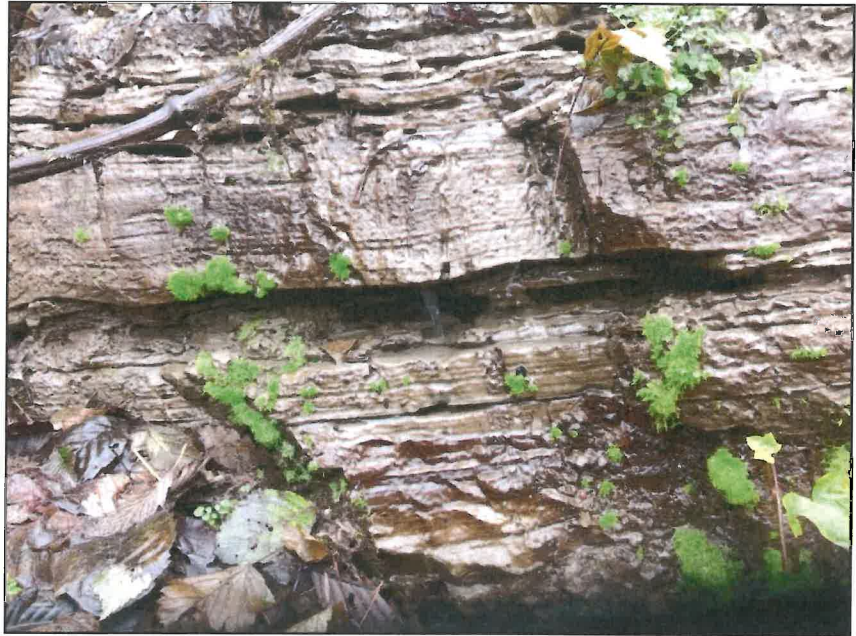
We observed irregular topography and groundwater seepage on the north side of the stairs. The seepage was occasionally near outcrops of interbedded sands and clay. These observations are consistent with previous observations made by GeoEngineers during our 2013 reconnaissance.

Seepage observed along clay layer exposed at base of slope, in 2012 landslide runout area.

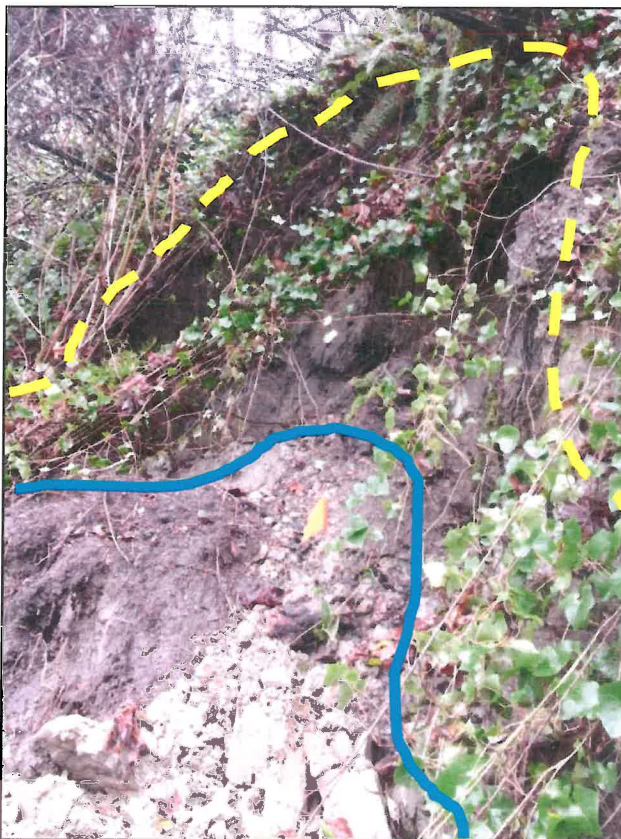
Recent movement and sloughing of headscarp of 2012 landslide. Note fresh piles of soil (outlined in blue) and lack of vegetation growing on the vertical scarp. Scarp (outlined in yellow) is estimated between 10 to 15 feet in height.

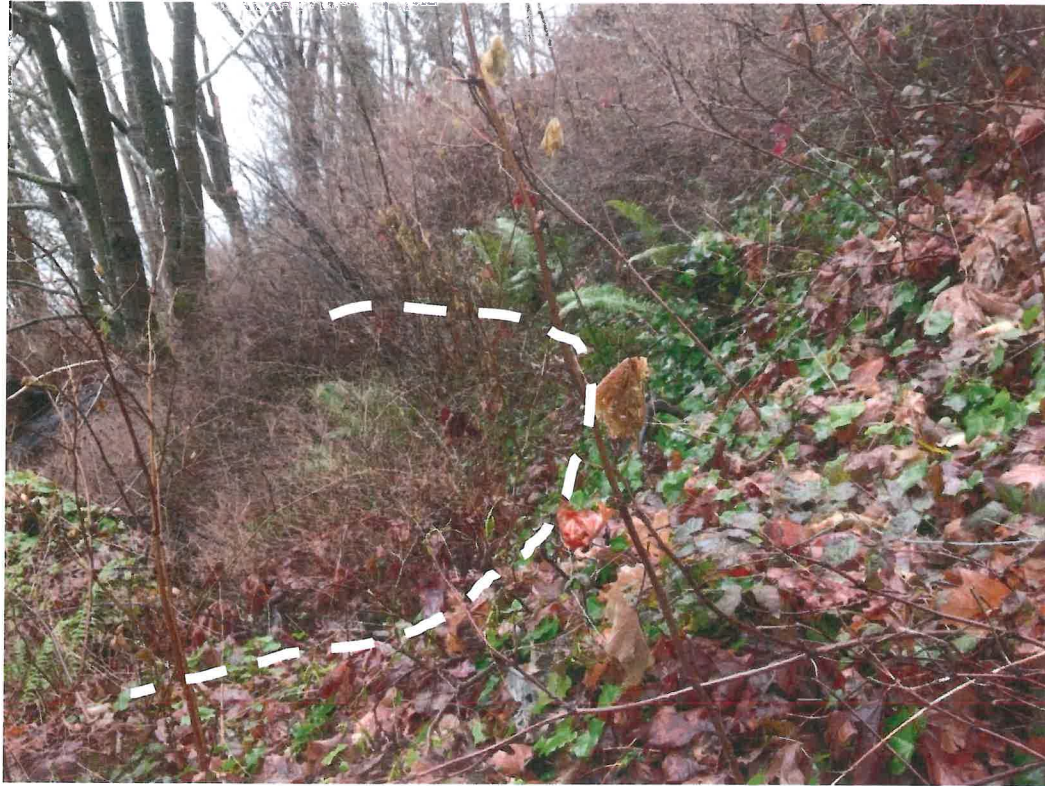
Site Photographs	
Eagle Landing Landslide Evaluation Burien, Washington	
GEOENGINEERS  	Figure 7

Older slumps above 2012 Landslide area (outlined in white). View facing northwest.
