July 12, 2016

City of Burien
400 SW 152nd Street, Suite 300
Burien, Washington 98166-1957

Subject: 2016 Eagle Landing Park Stairway Evaluation
Burien, Washington
File No. 3416-053-08

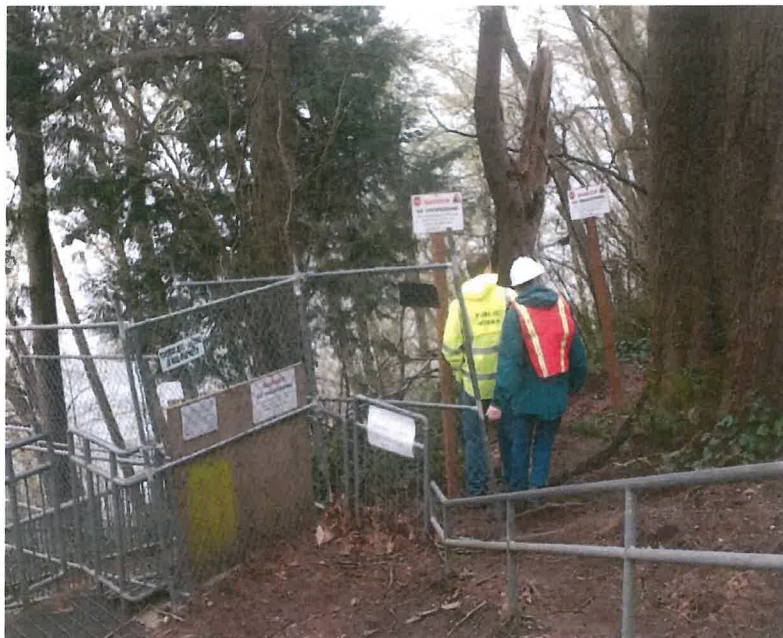
Photograph 1. View of Top of Stairway with Warning Signs

As we approached the crest of the slope where the stairway begins, we observed the warning signage placed by the City along with the fencing that had been placed to limit access to the stairs. However, an unauthorized trail was present along the north side of the stairway that followed along the stairway for the first two landings. In addition to the vertical fencing at the top of the head of the stairs, trail users were also restricted from using the upper part of the stairs by fencing that had been placed over the stairs. However, once this fencing ended, the remainder of the stairs could be accessed by park users that had climbed over the railing.

We recommend that the City further discourage pioneering of trails down the slope to reduce the potential for slips, trips and falls on improperly formed trails. This could be accomplished by fencing, signage, increased railing heights or other means.

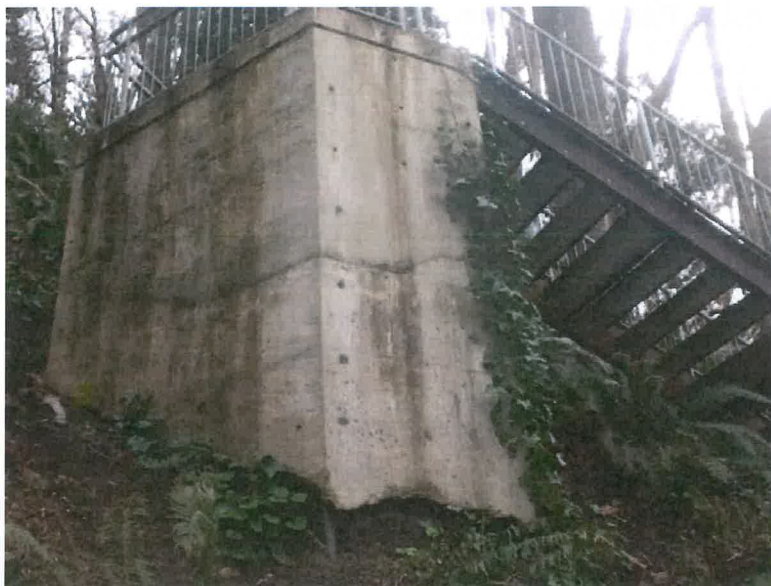
Photograph 2. Base of Landing 2

We observed no indication of significant slope movement adjacent to the stairs along the upper approximate three-quarters of the stairway and landings. Where exposed, the length of pipe piles supporting the foundations we observed at the landings was typically less than about 1 foot in height. This is consistent with the observations in December 2014, where erosion and creep had exposed up to about 6 inches (or more based on photograph 2 of our January 2015 letter) below portions of the landings. There was not any readily noticeable ground cracking or separation of the

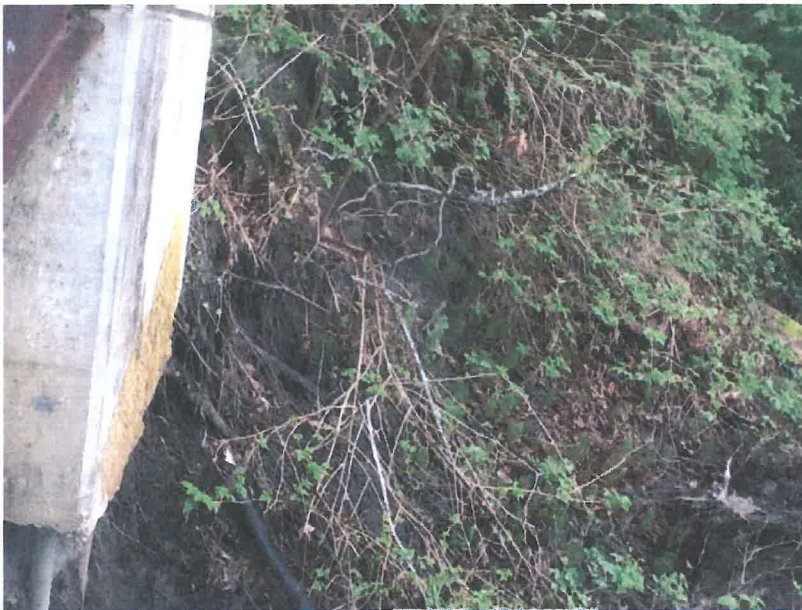
Photograph 4. Landing 9, located adjacent the 2014 Landslide

ground from the concrete landings foundation concrete until the landing located directly upslope from the now demolished and removed lowest landing. This landing is located next to the head of the landslide that affected the lowest landing.

Based on a map and other information in an email from Dan O'Brien to Galan McInelly, dated June 20, 2016, we understand that two leaning trees were located close to the stairway. One tree is a conifer leaning very slightly downhill and did not appear to be a risk to the stairway or users (see Figure 2). A second tree is a deciduous tree that leans downslope and is about 20 feet upslope of the landslide near Landing 9. If this tree fell, it is likely that it could impact Landing 9 and potentially impact users on the stairs.

In the last 1-½ years, the landslide adjacent to the stairways has regressed upslope about 45 to 50 feet. Therefore, it is reasonable to anticipate that within the next year or two, assuming the rate of regression upslope is the similar, both trees could topple from landslide activity. While it appears unlikely the conifer tree would fall on stairway users, it is likely that it would remove lateral support of Landing 7. This would leave stairway users at risk if the structure were to remain in place and was not blocked adequately from public use.

To reduce risk to trail users, we recommend that the landings and stairways from Landing 6 downslope be demolished and removed from the slope. Landing 6 should have railings installed that reduce the ability of users to jump over them.

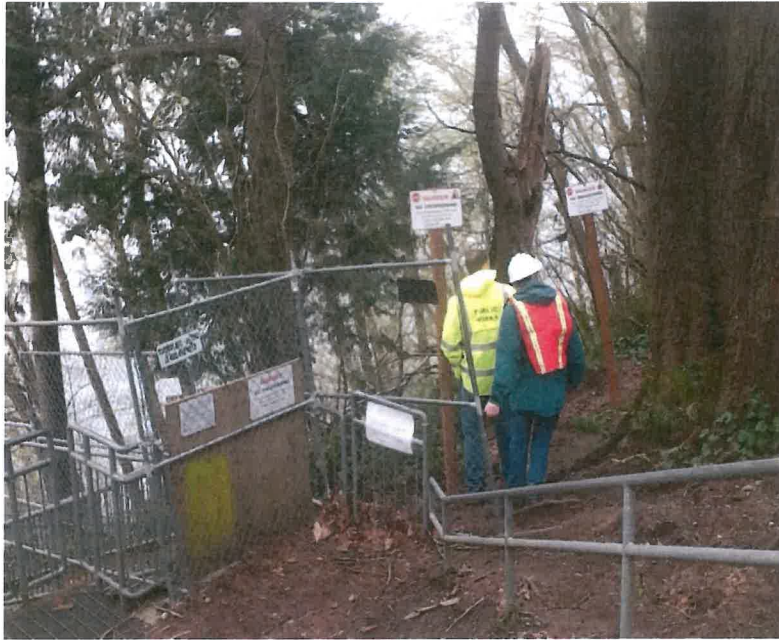
Photograph 1. View of Top of Stairway with Warning Signs

As we approached the crest of the slope where the stairway begins, we observed the warning signage placed by the City along with the fencing that had been placed to limit access to the stairs. However, an unauthorized trail was present along the north side of the stairway that followed along the stairway for the first two landings. In addition to the vertical fencing at the top of the head of the stairs, trail users were also restricted from using the upper part of the stairs by fencing that had been placed over the stairs. However, once this fencing ended, the remainder of the stairs could be accessed by park users that had climbed over the railing.

We recommend that the City further discourage pioneering of trails down the slope to reduce the potential for slips, trips and falls on improperly formed trails. This could be accomplished by fencing, signage, increased railing heights or other means.

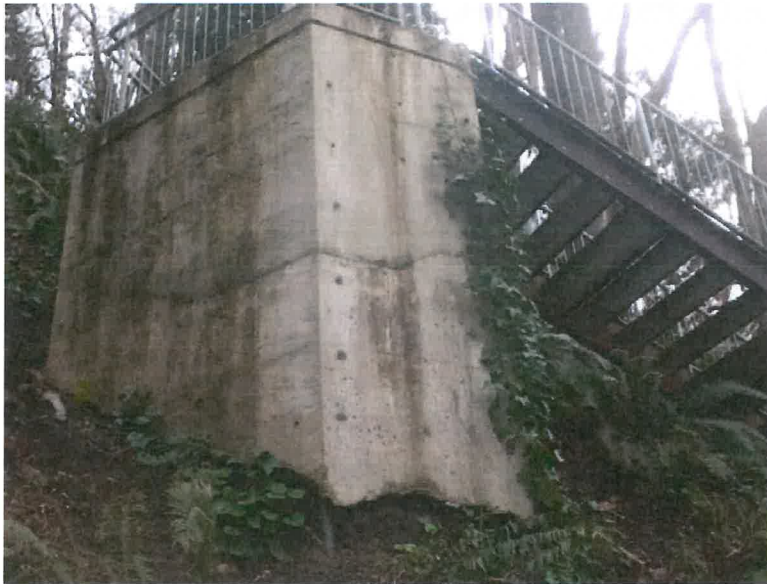
Photograph 2. Base of Landing 2

We observed no indication of significant slope movement adjacent to the stairs along the upper approximate three-quarters of the stairway and landings. Where exposed, the length of pipe piles supporting the foundations we observed at the landings was typically less than about 1 foot in height. This is consistent with the observations in December 2014, where erosion and creep had exposed up to about 6 inches (or more based on photograph 2 of our January 2015 letter) below portions of the landings. There was not any readily noticeable ground cracking or separation of the

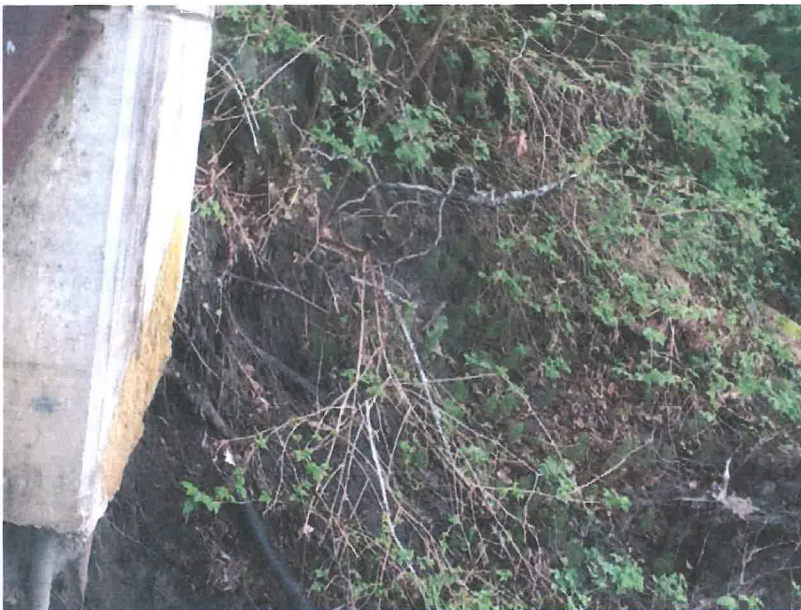
Photograph 4. Landing 9, located adjacent the 2014 Landslide

ground from the concrete landings foundation concrete until the landing located directly upslope from the now demolished and removed lowest landing. This landing is located next to the head of the landslide that affected the lowest landing.

Based on a map and other information in an email from Dan O'Brien to Galan McInelly, dated June 20, 2016, we understand that two leaning trees were located close to the stairway. One tree is a conifer leaning very slightly downhill and did not appear to be a risk to the stairway or users (see Figure 2). A second tree is a deciduous tree that leans downslope and is about 20 feet upslope of the landslide near Landing 9. If this tree fell, it is likely that it could impact Landing 9 and potentially impact users on the stairs.

In the last 1-½ years, the landslide adjacent to the stairways has regressed upslope about 45 to 50 feet. Therefore, it is reasonable to anticipate that within the next year or two, assuming the rate of regression upslope is the similar, both trees could topple from landslide activity. While it appears unlikely the conifer tree would fall on stairway users, it is likely that it would remove lateral support of Landing 7. This would leave stairway users at risk if the structure were to remain in place and was not blocked adequately from public use.

To reduce risk to trail users, we recommend that the landings and stairways from Landing 6 downslope be demolished and removed from the slope. Landing 6 should have railings installed that reduce the ability of users to jump over them.
