Subject: Letter Report
Eagle Landing May 2015 Site Visit
Burien, Washington
File No. 3416-053-05

INTRODUCTION AND SCOPE

Site Plan	
Eagle Landing Landslide Evaluation Burien, Washington	
 	Figure 1

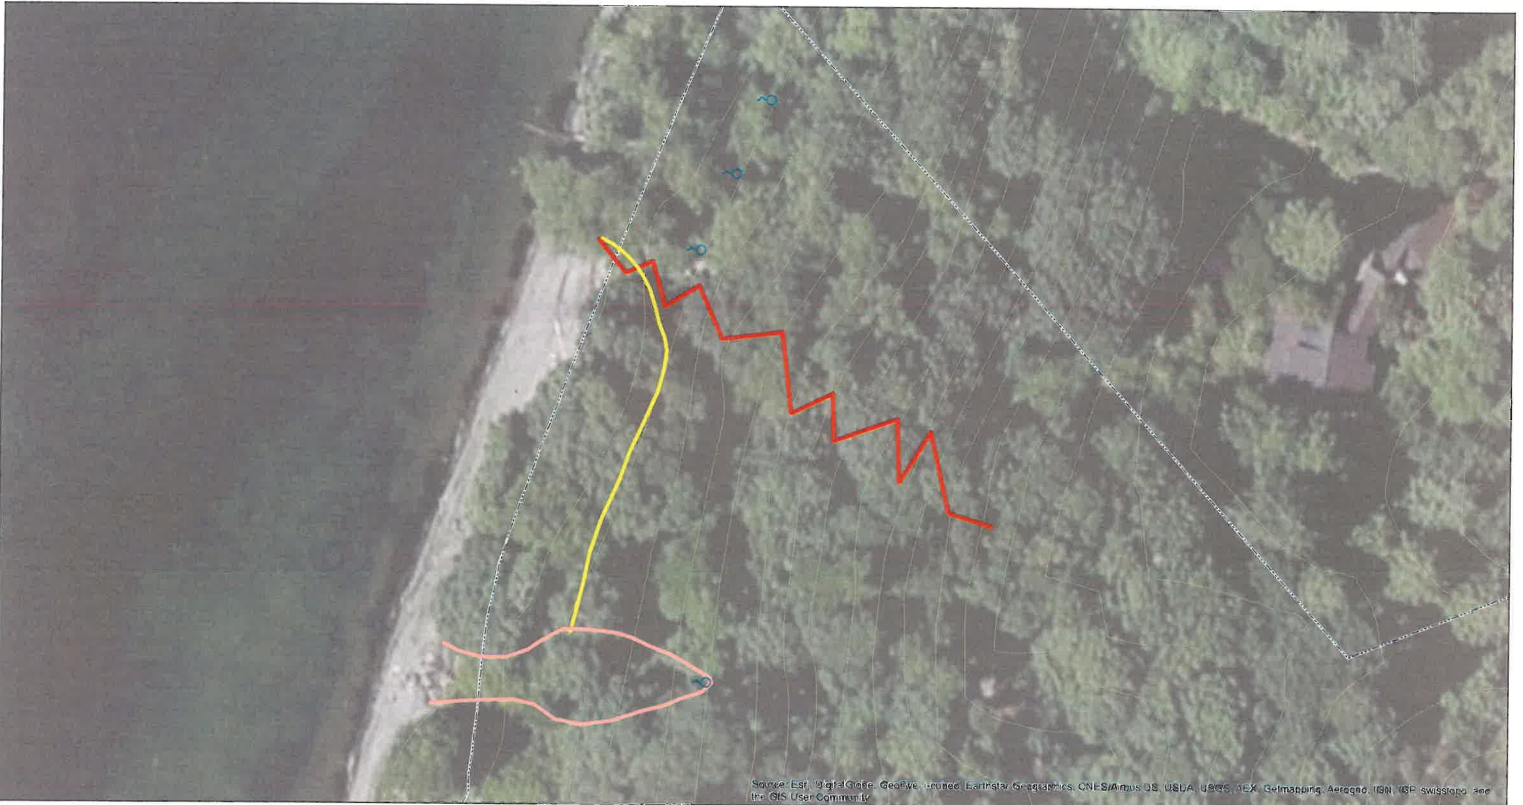
We completed a site reconnaissance at Eagle Landing Park on December 18, 2014 to evaluate the December 2014 slope failure located near the shoreline and near the lower sections of the stairs. This evaluation was conducted to develop a preliminary opinion regarding the cause of the slope failure, risk to public safety along the stairs and slope, and the potential risk for future slope failure. We were not able to complete a reconnaissance of the base of the slope or access the beach and shoreline at that time due to the high tide and the unstable and unsafe condition of the slope. A detailed summary of the December 2014 site reconnaissance is presented in our "Eagle Landing Landslide Evaluation" memorandum dated January 15, 2015. A site plan from that memorandum documenting site conditions is presented in Figure 1.
