January 5, 2015

City of Burien
400 SW 152nd Street, Suite 300
Burien, Washington 98166-1957

Subject: Memorandum
Eagle Landing Landslide Evaluation
Burien, Washington
File No. 3416-053-04

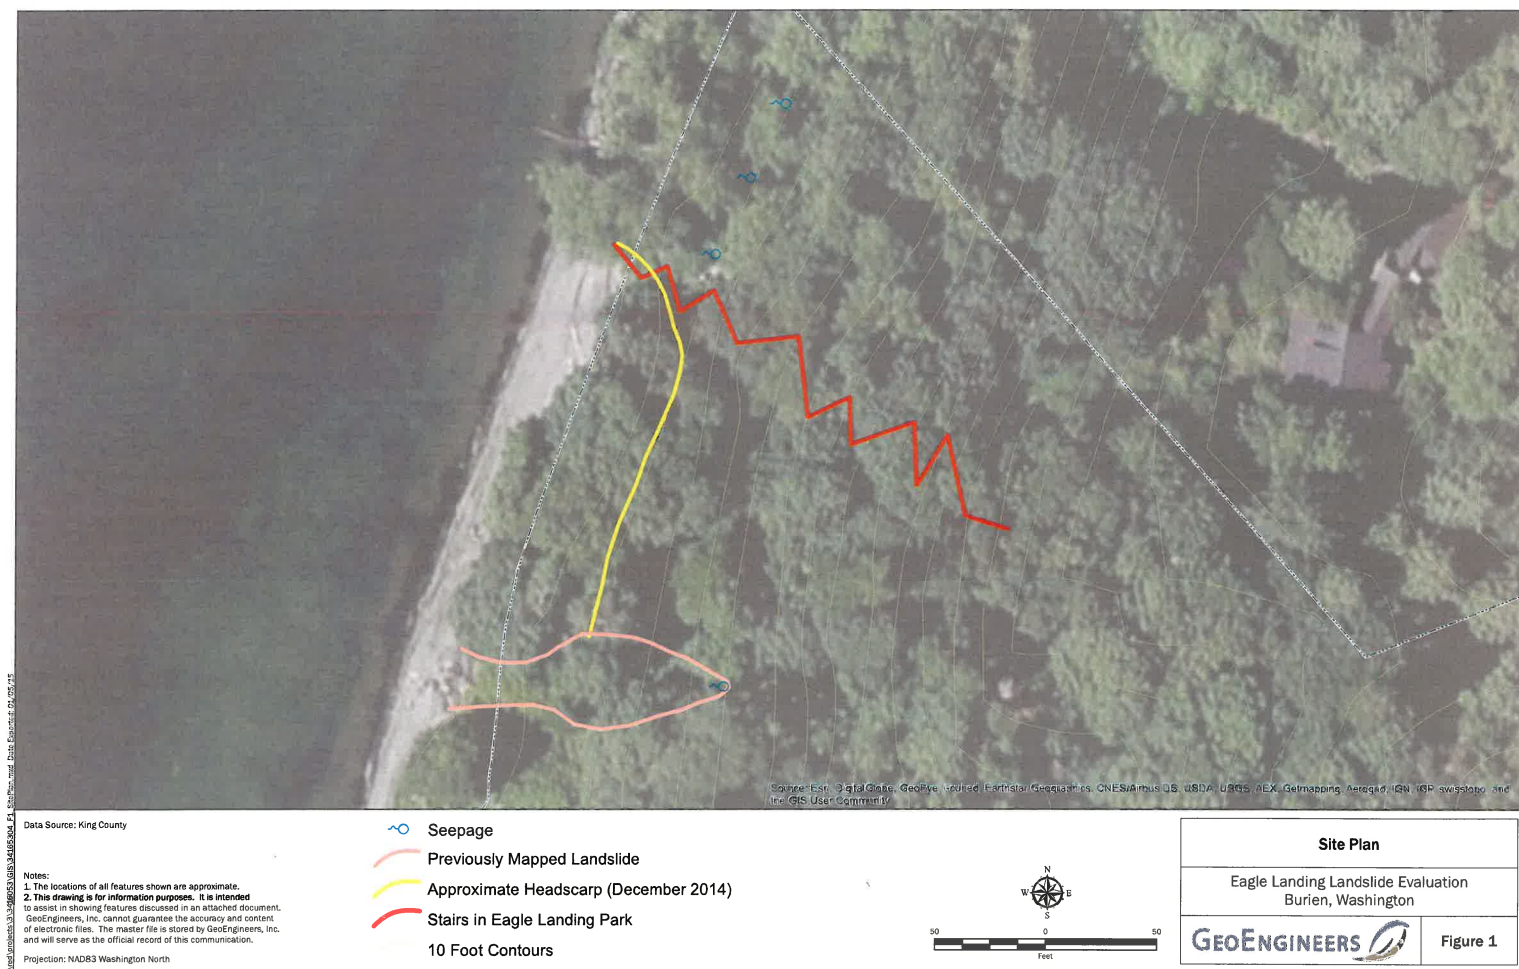
Site Photographs	
Eagle Landing Landslide Evaluation Burien, Washington	
GEOENGINEERS  	Figure 2

We visually inspected the stairs and concrete support platforms. We observed that erosion and soil creep has exposed up to 6 inches of the base of the concrete platforms for most of the stairway (Figure 2). We did not observe cracks or indication of movement for most of the platforms. Near the base of the slope, we observed that recent wave action had removed soil from the toe of the slope and from around the two concrete platforms at the base of the staircase, exposing the steel piles beneath the platforms. It appeared that the second platform from the bottom has been rotated by the slope movement and has detached from the stairs above (Figure 3). We were not able to access the beach due to high tides, but we did observe several recently downed trees along the beach, north of the stair access. We also observed that portions of the slope at the base of the stairs has been undercut several feet by wave action.

Typical erosion and soil creep observed at the base of one of the stair concrete platforms.
